**A POST-IMPACT BEHAVIOR OF PLATELET-BASED COMPOSITES
PRODUCED BY COMPRESSION MOLDING**

A Thesis Submitted to the Faculty of
Old Dominion University in Partial Fulfillment of the Requirements
for the Degree of

MECHANICAL AND AEROSPACE ENGINEERING

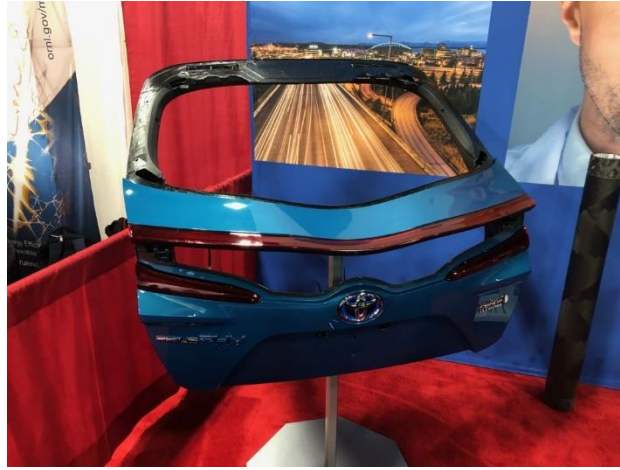
Fig. 3: Rear door of the new Toyota Prius, made of prepreg platelet molded composites.

A major reason why it is necessary to research and understand these composites can be seen in Fig. 3, a door of the new Toyota Prius. Every year, 40,000 people die as the result of vehicular injury [8], [9]. While this is not usually the fault of a certain material, this platelet molded composite material could present new dangers in car crashes. Even though advancements in materials allow new uses, they also present new potential dangers. Vehicles are unsafe modes of travel, so as more prepreg platelet molded composite parts are used in vehicles, impact with these composites become more likely. In impact, these composites become sharp, brittle edges, which could cause severe harm in a collision. Studying the fracture of these composites can allow better design of structure to decrease the likelihood of injury, and allow the industry to understand just how much damage these materials can take before they become a danger. Compression After Impact (CAI) testing is used to determine the impact resistance of the material.

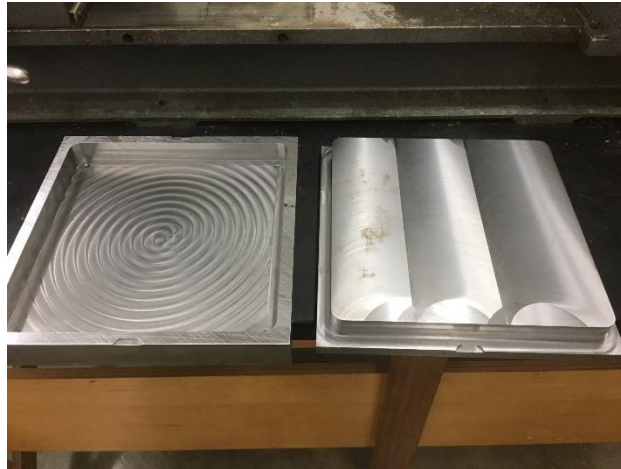
Fig. 5: Mold used to make 254 mm plate.

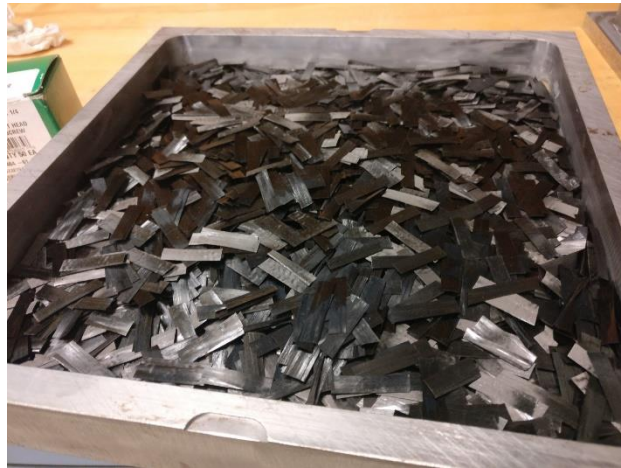
Fig. 6: Mold used to make 254 mm plate filled with platelets.

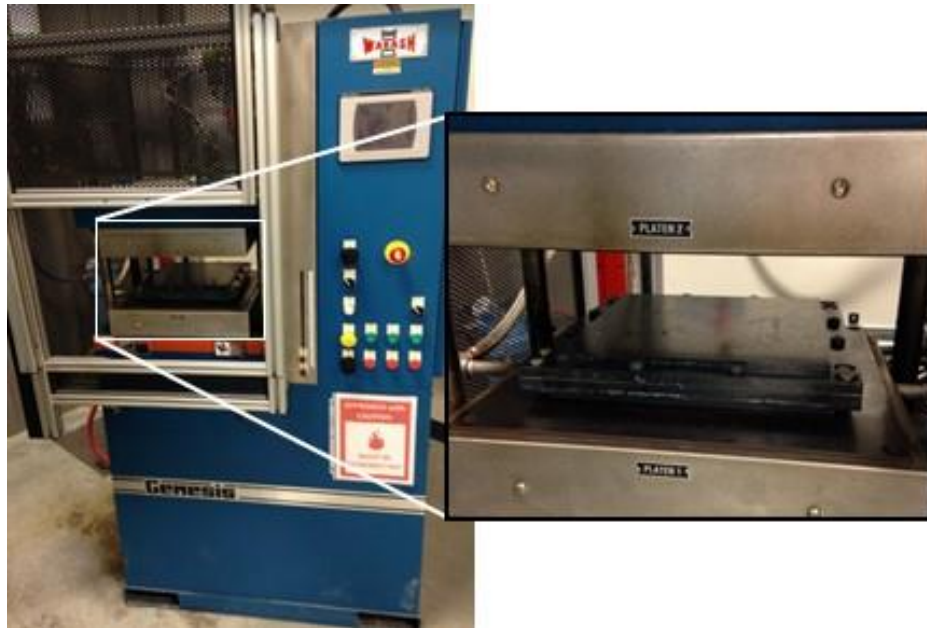
Fig. 7: Heated press used for making prepreg platelet molded composites.

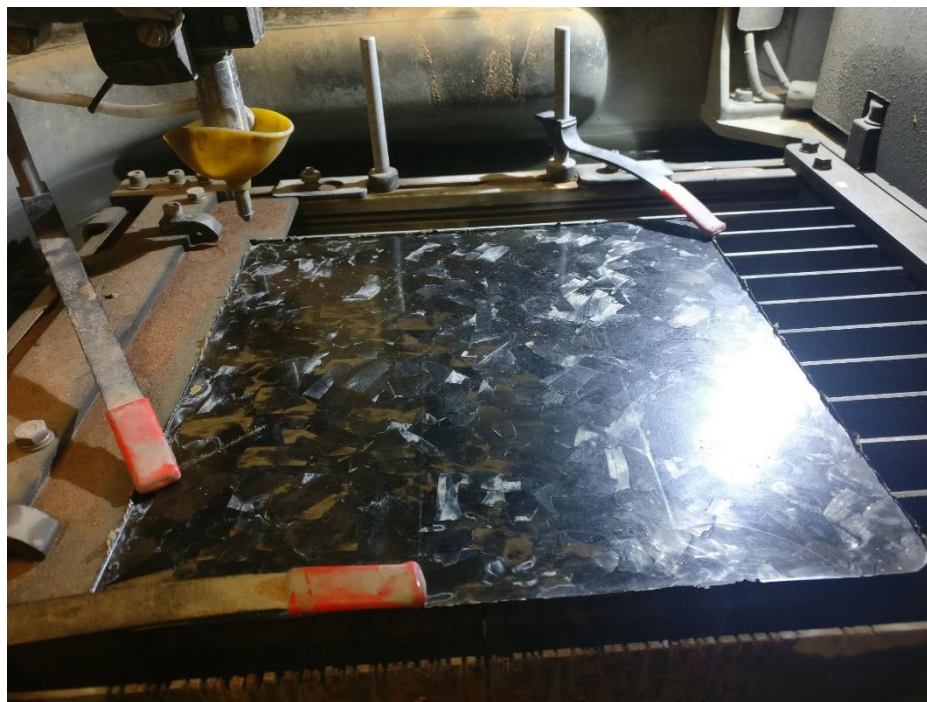
Fig. 8: Panel of 25.4 mm platelet material in the waterjet. The panel is ready to be cut into 9 specimens for testing.

Both types of panel were then cut into 76 mm by 76 mm specimens using a waterjet machine and measured in all dimensions in preparation for impact and compression testing. Figure 8 shows a finished 25.4 mm plate ready for waterjet cutting.

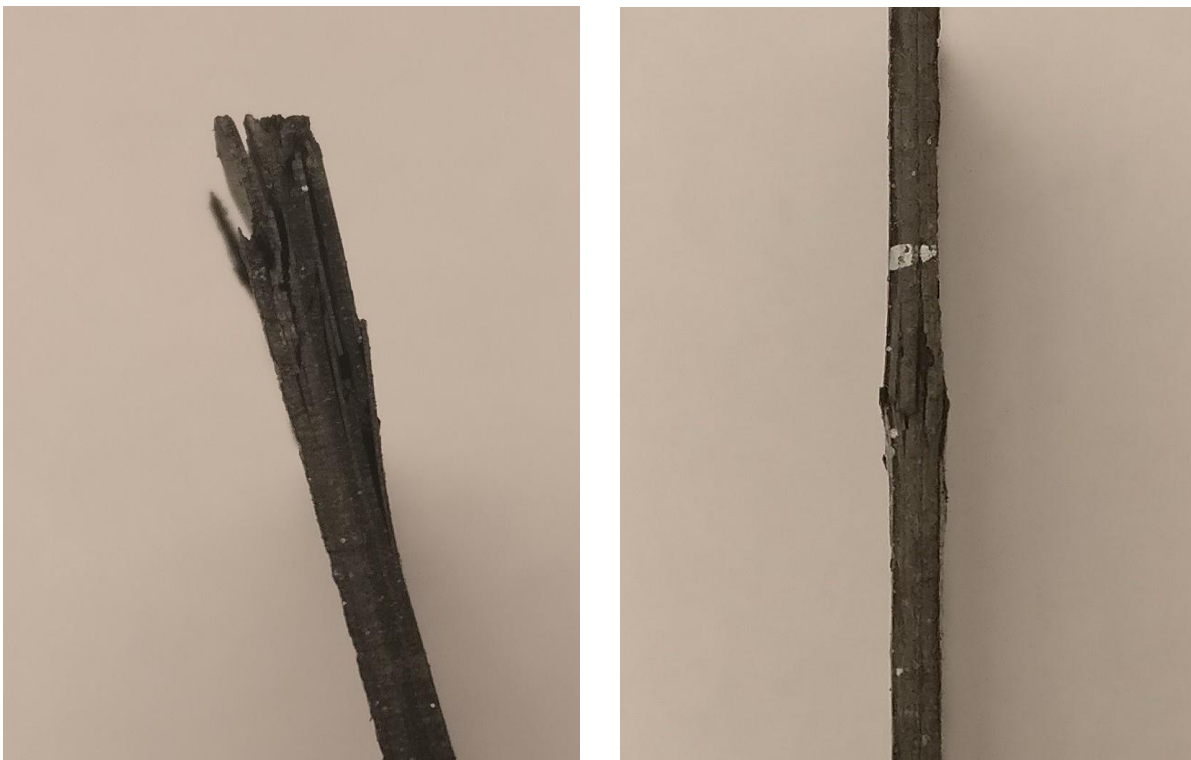
(a) Brooming of the loading edge of a specimen. (b) Pinching of a specimen edge.

Fig. 11: Undesirable failure artifacts.

Brooming is a phenomenon where force is applied to the specimen and the edges of the specimen fray, spreading out to resemble the end of a broom, as shown in Fig. 11(a). This phenomenon was avoided by designing the compression fixture to apply an out-of-plane force to these edges. Pinching can occur between the top and bottom pieces of the fixture during compression. When this occurs, the specimen's sides bulge out as a result of delamination. Extreme pinching of the specimen was avoided by rounding several edges of the fixture in contact with the specimen. Pinching was not observed in discontinuous fiber materials, though an example of pinching can be observed in Fig. 11(b).

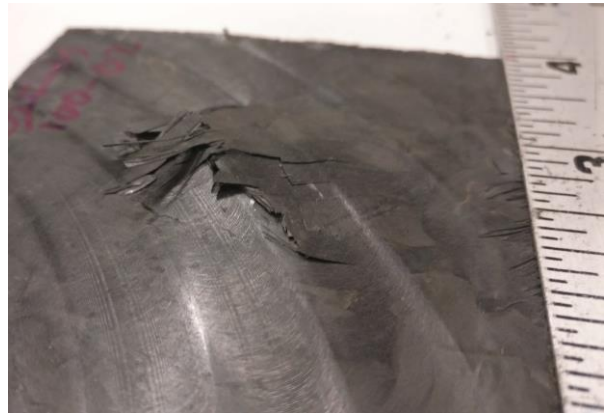
Fig. 17: Specimen from P902 tested at 10 J.

The UT before impact testing shows a specimen with several edge delaminations in lighter colors due to cutting, in Fig. 17(a). Another UT was taken after impact, showing the damage due to impact in darker sections in the middle of the specimen, in Fig. 17(b). There is significantly more damage in the 10 J specimen than that of the 2.5 J specimen from Fig. 16(a).

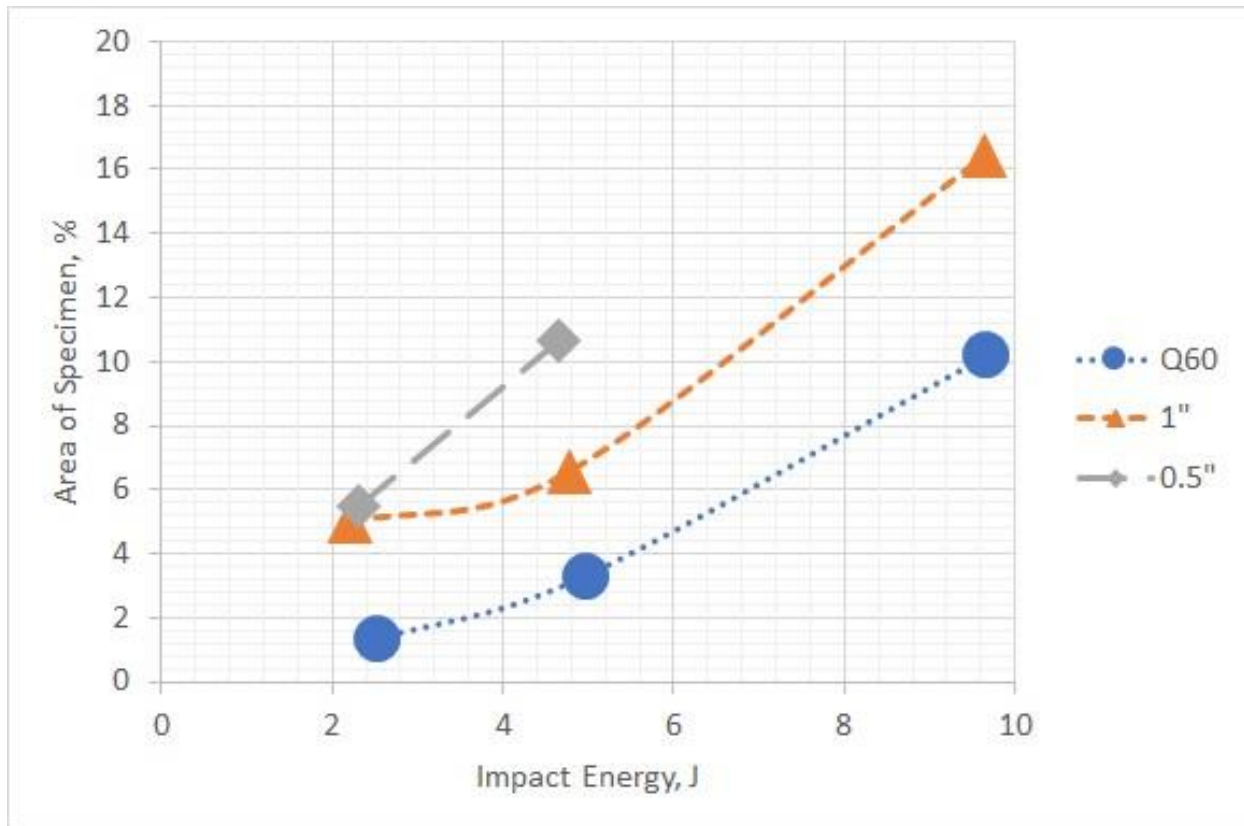
Fig. 19: Delamination area as a percent of total area vs impact energy.

Delamination area vs impact energy was explored and the results are presented in Fig. 19. Due to scatter, information was averaged. These values do not use all tested specimens due to missing data. Significant delamination occurred in discontinuous fiber specimens, compared to continuous fiber specimens.

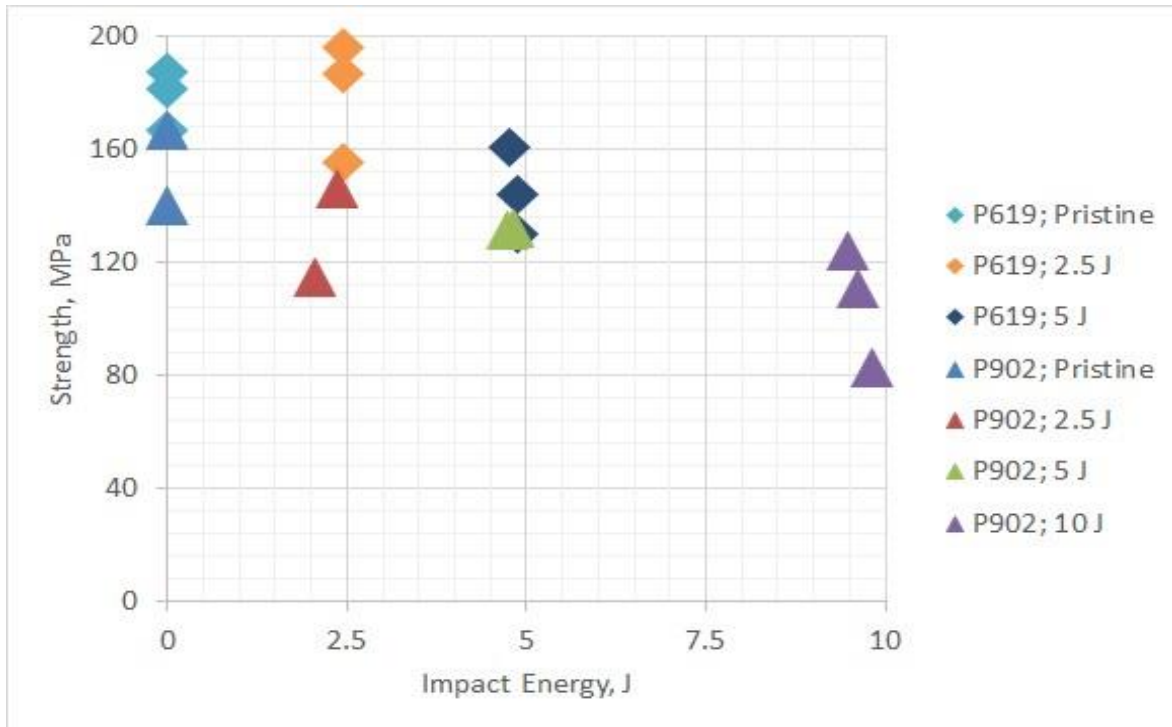
Fig. 21: Data from 25.4 mm platelet panels adjusted for actual impact energy.

Results of all compression and CAI tests are reported in Fig. 20, 21, and 22. Specimens markers with no fill failed under the specimen fixture, or due to buckling of the specimens and were not used in calculations. In each graph, there are two specimen shapes correlating to which panel the specimen was from. Results of each energy level were averaged and are presented in the discussion. All data has been adjusted for recorded impact energies.

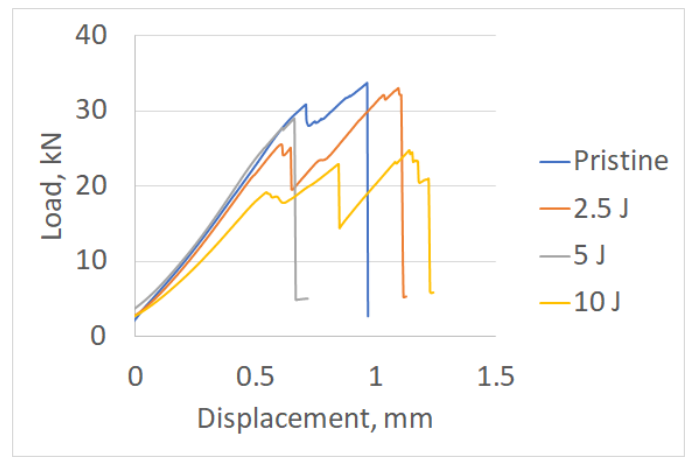
Fig. 23: Stress–strain curves for each material type at all impact energies.

Stress-strain curves for each material are presented in Fig. 23. Axes are generalized between figures for better comparison of data. Specimens were tested until the final failure resulted in values less than half of the current maximum load.

Pristine 25.4 mm specimens had a median modulus value of 9.1 GPa. The modulus decreases with increasing impact energy levels, as seen in Fig. 23(b). This trend is also seen with the 12.7 mm specimens, as shown in Fig. 23(c). Pristine 12.7 mm specimens had an average modulus of 8.5 MPa. It is worth noting the curves become more rounded with decreasing fiber length. The likely reason for this is damage propagation may be easier with shorter fibers due to the inability of the matrix to carry as much load as the fibers. Shorter fibers/platelets would also mean fewer fibers in contact with one platelet, and thus lower surface area for load transfer.

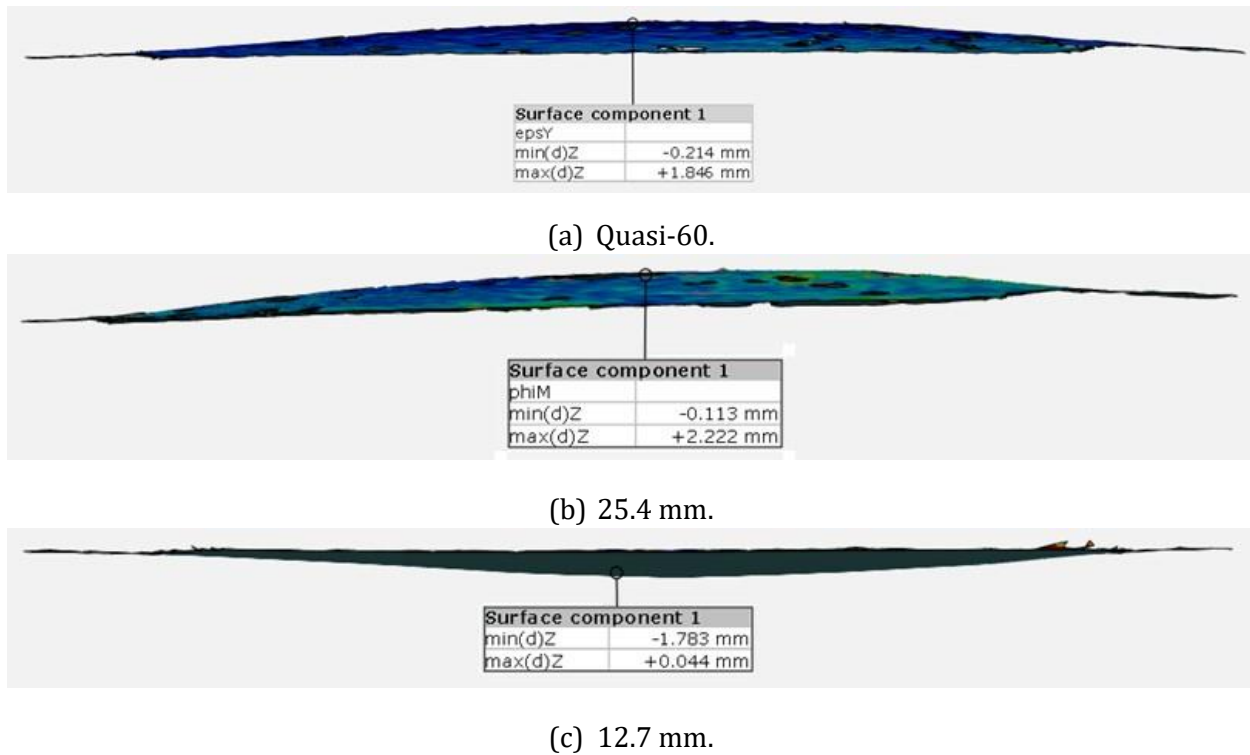
Fig. 24: Out-of-plane deflection of several sample specimens.

The critical buckling stresses using Eq. 5 for Quasi-60, 25.4 mm, and 12.7 mm materials are 160 MPa, 110 MPa, and 110 MPa, respectively. This calculation used a critical buckling factor of 7 for fixed supports, a Poisson's ratio of 0.3, average material thickness of 1.7 mm, and average specimen width of 76 mm. The moduli can be found in Table III, along with the average experimental strengths and predicted buckling stresses. The Quasi-60 material's predicted critical buckling stress was lower than the average ultimate stress experienced by the material at 277 MPa; however, the 25.4 mm materials' predicted buckling stress was lower than the experienced average ultimate stress of 169 MPa. The 12.7 mm material's buckling stress was below the average maximum stress. The out-of-plane deflections taken at the point just before failure can be seen in Fig. 24.

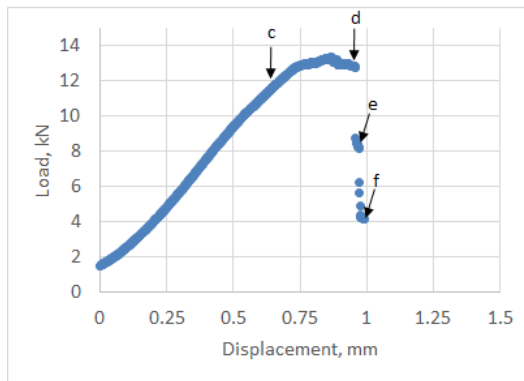
Fig. 27: DIC of a 25.4 mm specimen impacted with 2.5 J of energy.

An impacted specimen for the 25.4 mm material is shown in Fig. 27. This figure contains a load vs displacement graph, UT after impact, and four stages of DIC. Catastrophic failure occurs between Fig. 27(d) and Fig. 27(e). The final stage in the DIC of this test is given for reference of crack propagation. As with most of the damaged specimens, cracks begin at the location of impact and spread to the edges. Cracks appeared to follow platelet edges, but generally appeared to propagate in more smooth, arcing methods.

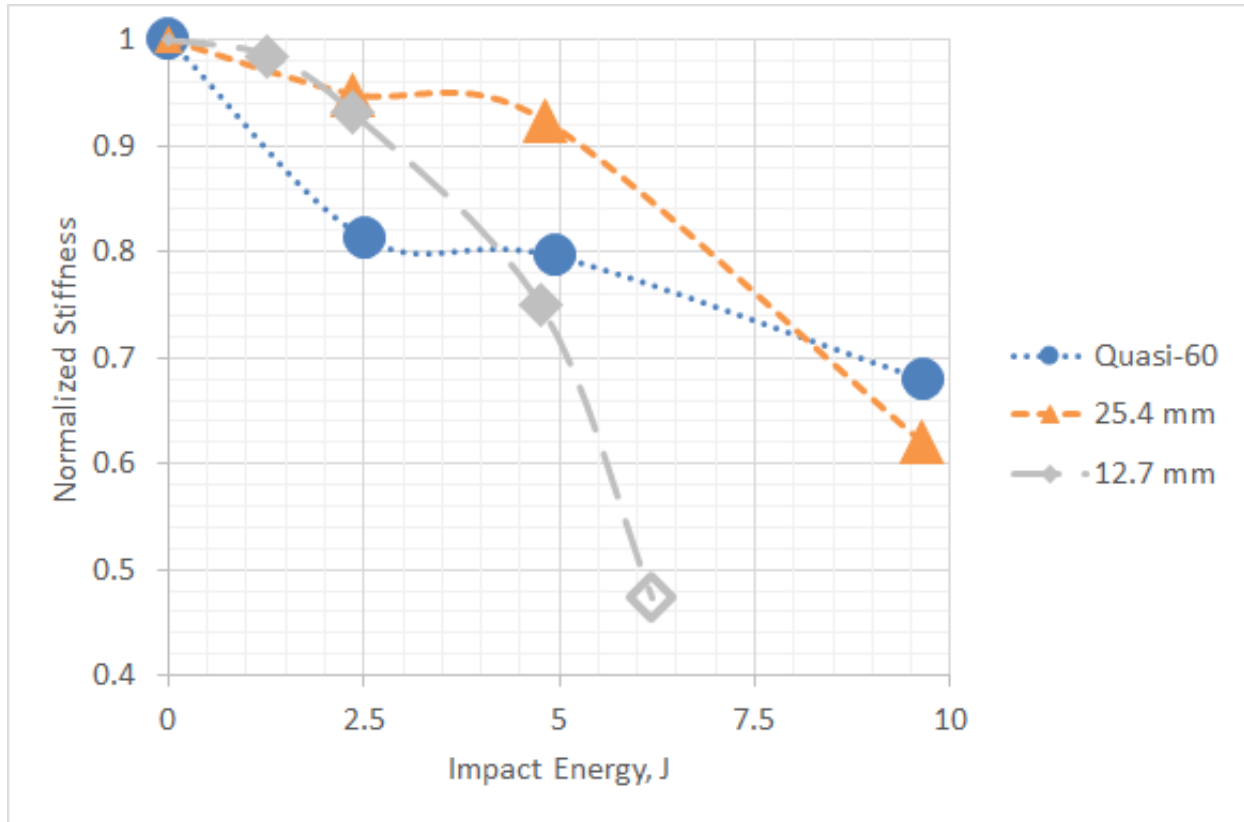
Fig. 31: Normalized Modulus for all tested materials.

The normalized stiffness is shown for all materials in Fig. 31. This stiffness is calculated from the MTS crosshead displacement. The discontinuous fiber materials decrease similar to an open-end-down parabola, while the continuous fiber material had a more erratic trend downwards, similar to strength.

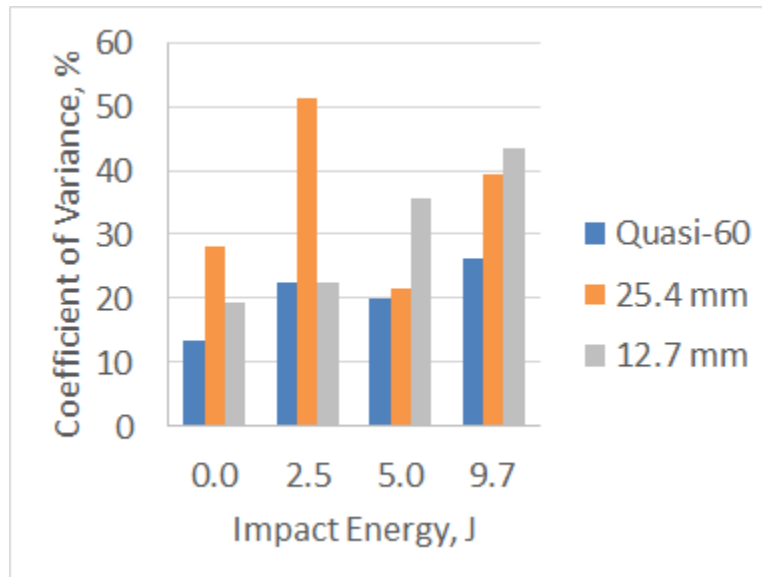
Fig. 32: Coefficient of Variance using the ranges of the sample sets

It was determined the standard deviation was not a good representative for a low quantity of data. Therefore, the coefficient of variation was explored using the range of the data at a given energy level. These are presented at the intended impact energy level in Fig. 32. The coefficient of variation appeared to increase with increasing impact energy, but no conclusions can be made due to the fluctuation in the coefficient.
