**DIURON FROM MAUI SUGARCANE FIELD RUNOFF IS
POTENTIALLY HARMFUL TO LOCAL CORAL REEFS**

Thomas C. Royer, Patricia A. Tester, and Thomas N. Stewart

Atoll Research Bulletin No. 605 ♦ 8 October 2014

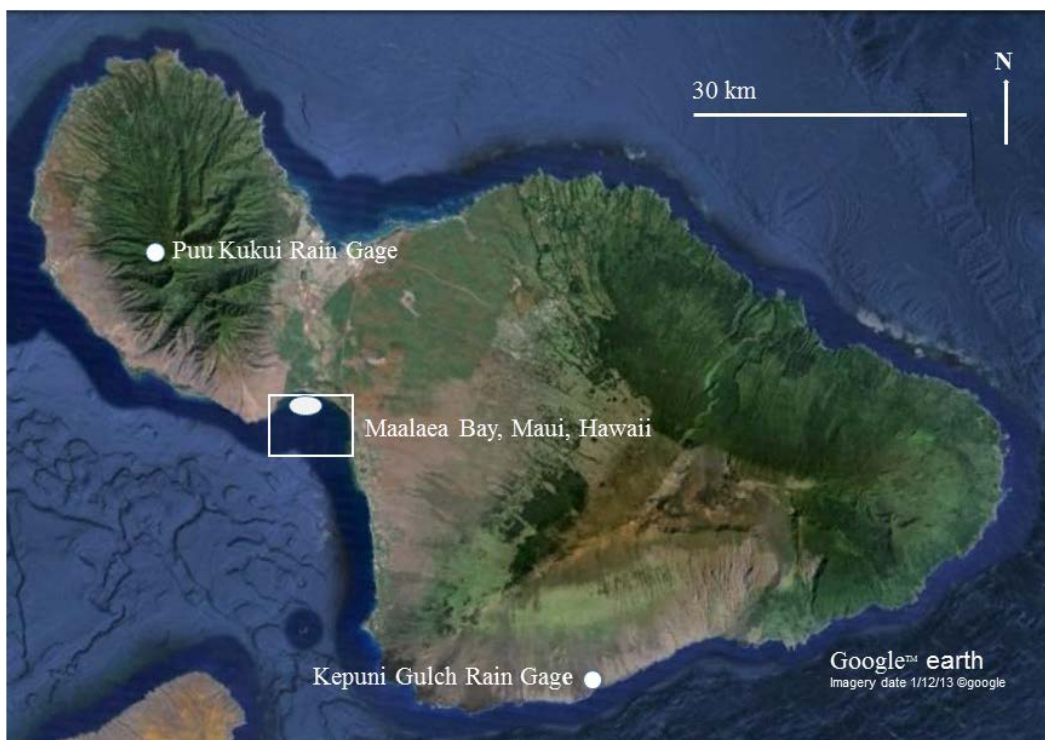
Figure 1. Maalaea Bay (square) and sampling site (oval), Maui, Hawaii, in relation to the local topography. The two rain gauges on Maui, Hawaii, are at Puu Kukui, Maui, Hawaii, in the north at 1,759 meters elevation and at Kepuni Gulch along the southwestern coast at 77.7 meters elevation (<http://hi.water.usgs.gov/recent/hawaii>). Data: LDEO-Columbia, NSF, NOAA, U.S. Navy, NGA, GEBCO. Image: Landsat. © 2014 Google.

Maalaea Bay is on the south central shore of a valley-like isthmus formed by erosional deposits from two overlapping volcanoes on Maui, Hawaii (20°44'36" N, 156°30'22" W) (Kyselka and Lanterman, 1980). The older, northwestern volcano is Puu Kukui (1,759 m). Haleakala is to the southeast, rising to 2,000 m (Figure 1). Maui's climate is characterized by annual wet and dry seasons, dominant trade winds from the north-northeast and marked geographic differences in rainfall related to topography. Maalaea Bay is on the leeward side of Maui and somewhat shielded from the trade winds. It is in the rain shadow of the mountains and experiences dry conditions except for sporadic showers associated with ephemeral frontal systems. Maalaea Harbor is at the northwestern-most part of the bay and separated from the coastal water flow from the south by a breakwater.

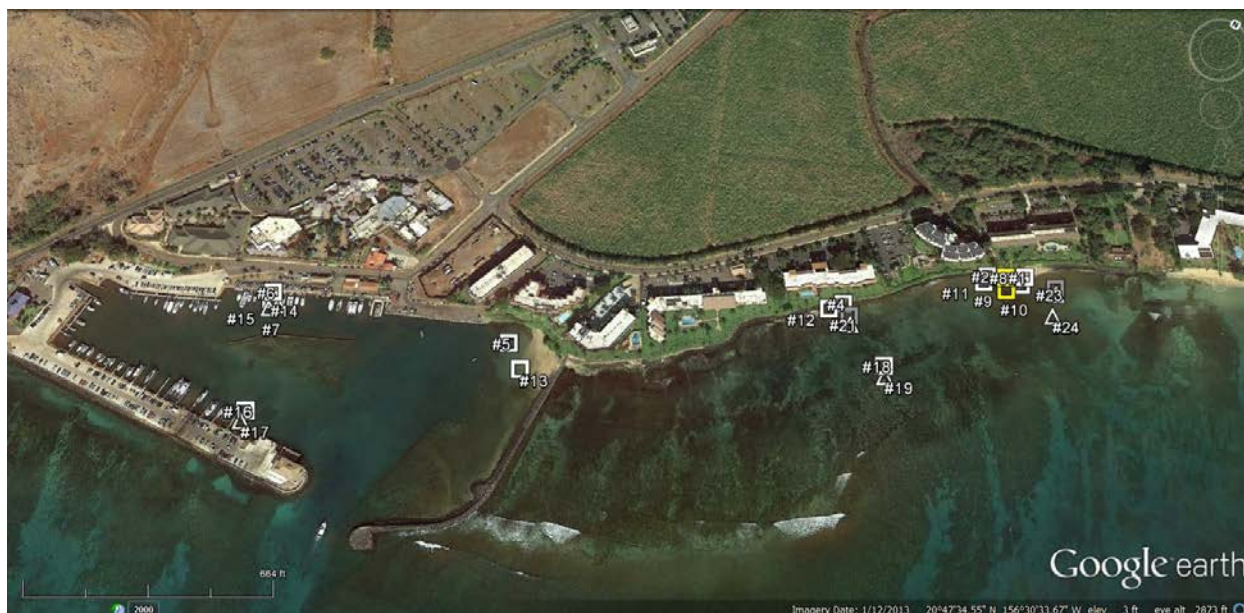
Figure 2. Sampling locations along Maalaea Bay, Maui, Hawaii. White squares indicate surface samples, white triangles indicate subsurface samples, and yellow squares mark stations that tested positive for Diuron in concentrations greater than 3 ppb (#8 and #9). © 2014 Google.

Water sampling took place before, during, and after the passage of Tropical Storm (TS) Flossie on July 29, 2013. It began on July 28 and ended six days later on August 3, 2013. Samples 1–2 and 4–7 were taken near the shore, from Island Sands Resort Condominium complex to Maalaea Harbor (Figure 2; Table 1) prior to TS Flossie. Sampling was repeated after TS Flossie (Samples 10–15). Samples 6, 7, 14 and 15 were taken on the northern side of the harbor. Samples 8 and 9 were drawn during TS Flossie from the runoff stream immediately east of Island Sands Resort Condominiums. Additional post-TS Flossie samples (16–17) were obtained on July 31 at Maalaea Harbor. Using a kayak on August 3, 2013, seven additional samples were gathered over the reef (Samples 18–24). One blank sample (Sample 3, distilled water) was added to the group as a control, making 24 samples in all.
